# MUSEUM OF ARTS AND DESIGN

Mad World

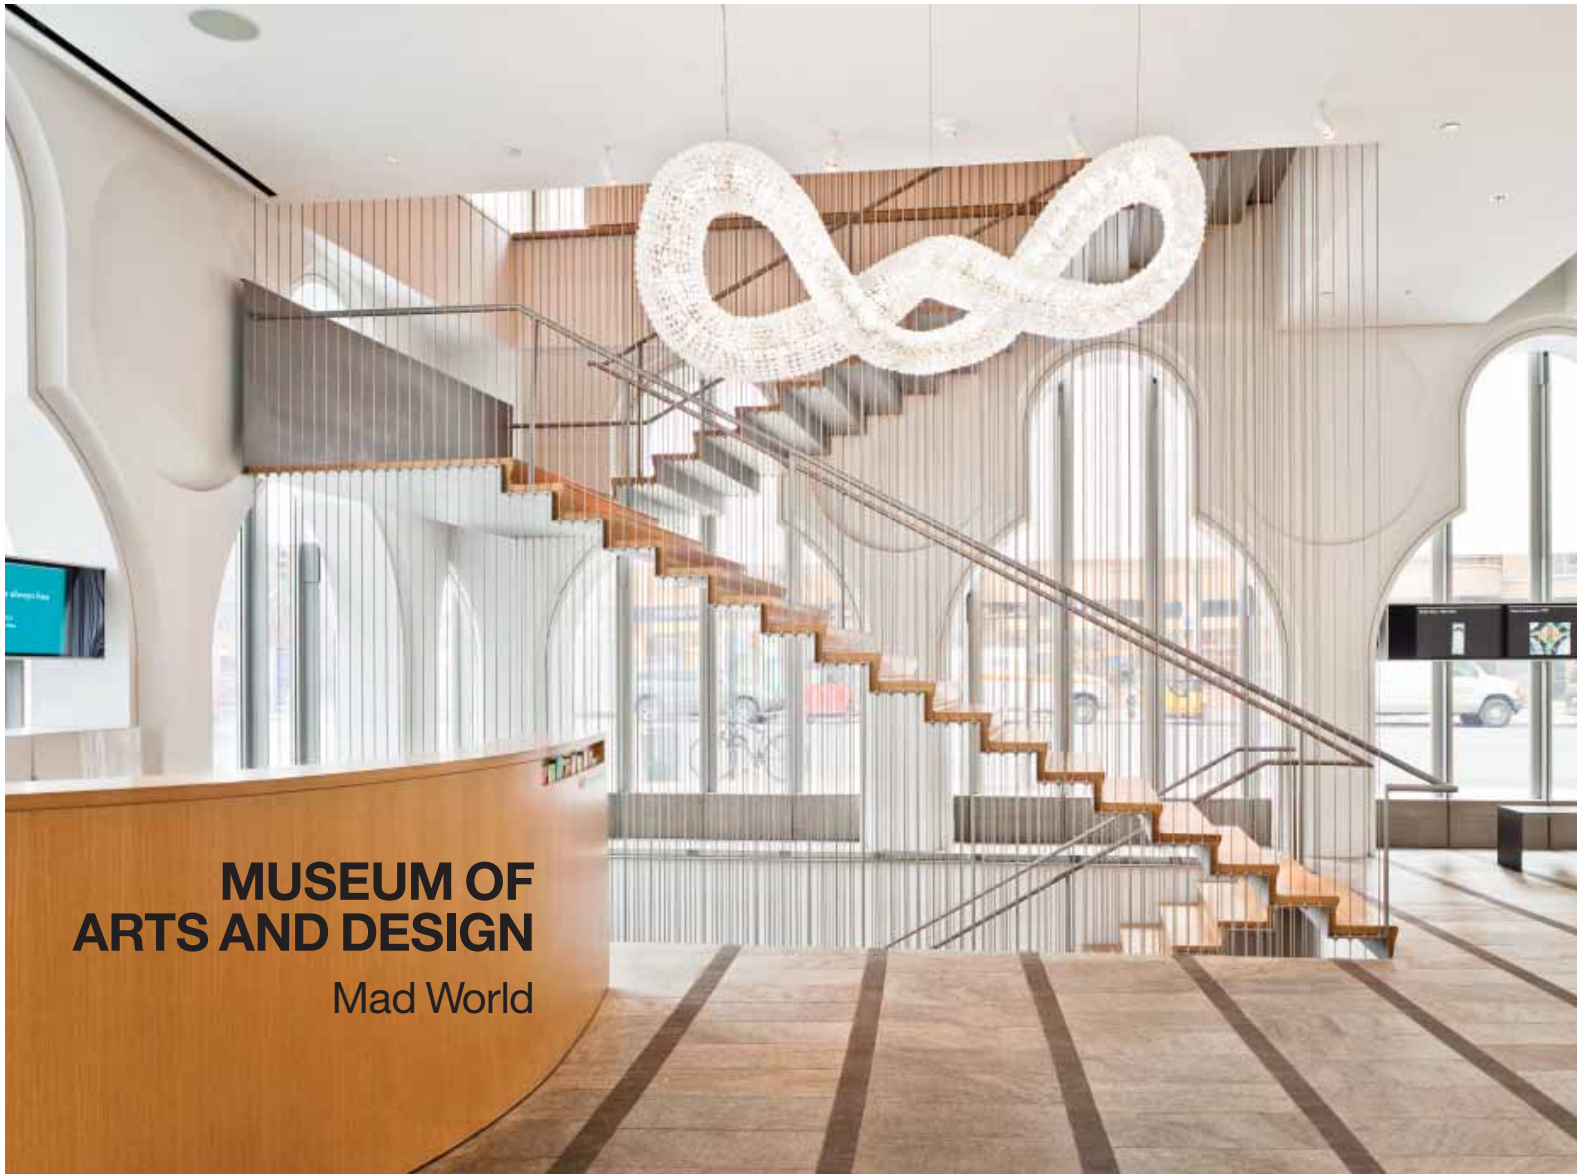
**Previous spread** Though it occupies valuable space in the museum's ground floor, the stair fulfils the architect's vision of a transparent, floating structure that allows visitors to move between floors with ease. The lobby also features Yves Behar's Swarovski crystal chandelier, *Mini Voyage*.

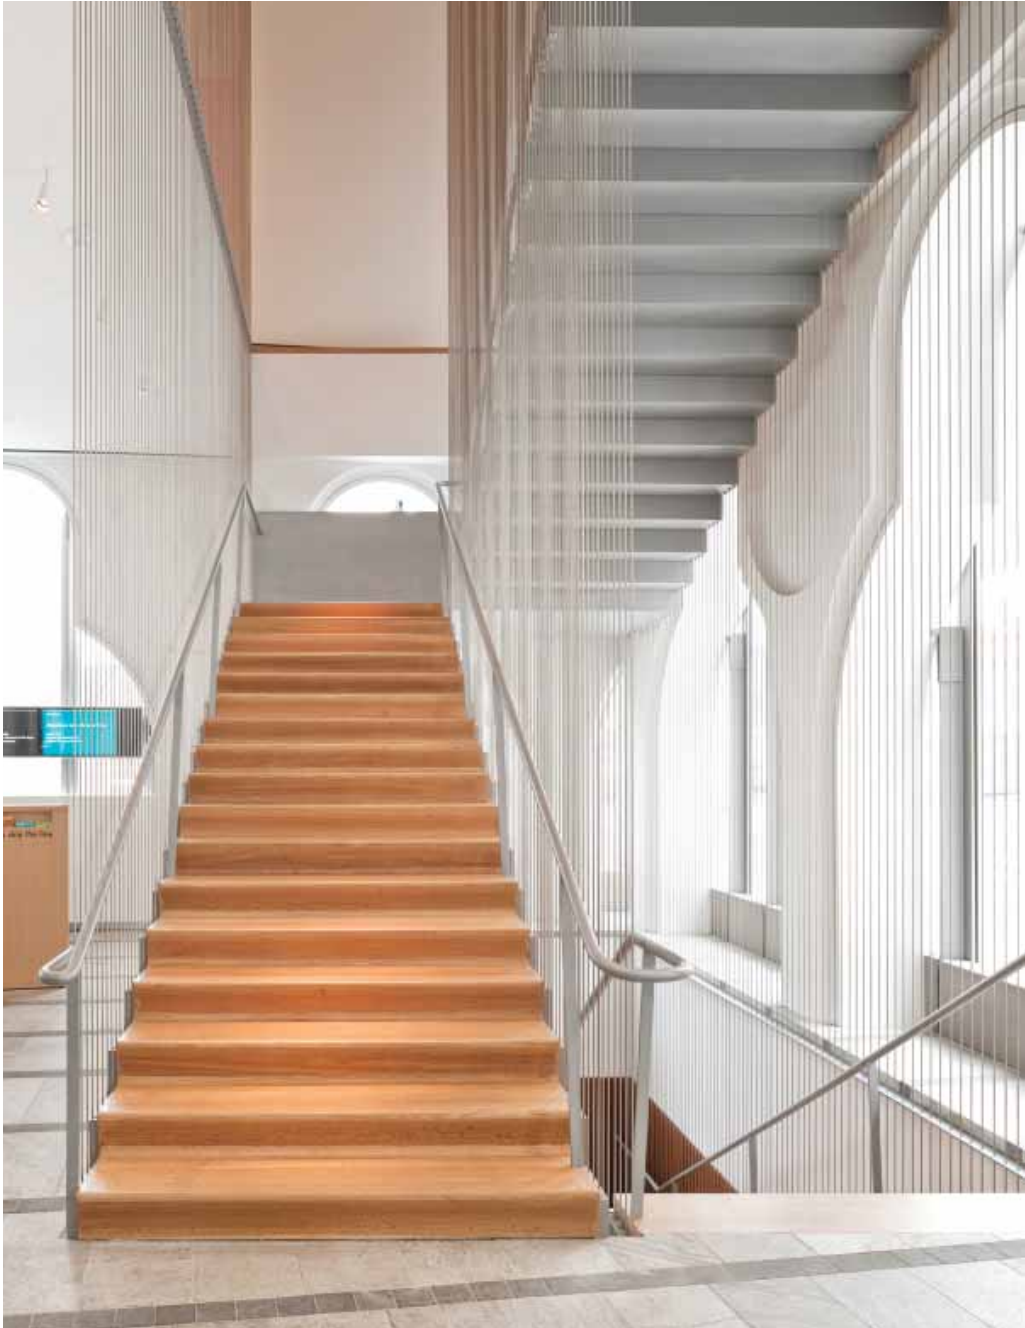
**Facing** Three-eighths-inch-thick A36-grade steel plates were welded together to form the stair's risers and treads, which were assembled in four main sections with two landings.

UI's first step was to fabricate the ¾-inch-thick A36-grade steel plate that appears to run among the three floors without a seam. Steel plates were welded together to form the stair's risers and treads. Then each fully welded plate combination was welded to the next riser-tread module. The stair assembled into four main sections with two separate landing sections; Rifelli says his team used partial-penetration welds at each plate connection throughout the stair. Because four cables penetrated each tread, and each cable is single-span, "the cable ran through four points of the stair and it was critical that they line up perfectly," Rifelli says. "The visual vertical alignment is what provides the architectural splendor. To weld each plate to each other and to accurately drill the multitude of holes for the cable spacing was the tough part. To our surprise the lineup of the holes was better than expected."

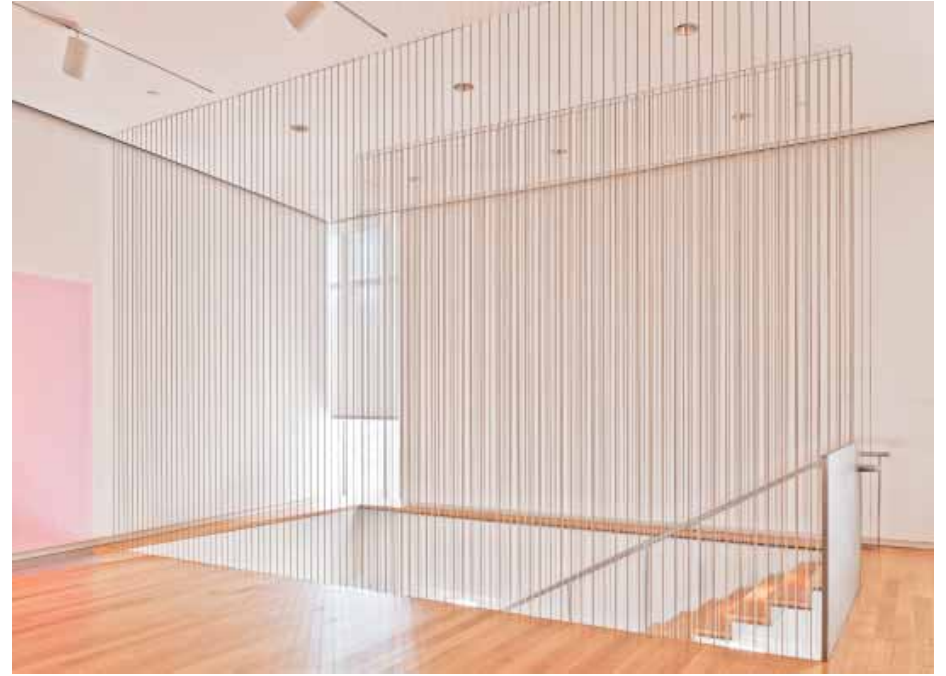
**Above** The stair hangs from the second-floor gallery ceiling on 300 Jakob Inox 6mm 1x19 stranded-wire cables.

Realizing this vision of something so sheer that it didn't visually intrude in the small lobby required some literal heavy lifting. The stair, which extends from the cellar floor to the second-floor gallery ceiling, is suspended on 300 Jakob Inox 6mm 1x19 stranded-

wire cables tensioned to approximately 900 pounds. Each of the woven stainless-steel stringers, which list a minimum breaking strength of 22.0 kN, measures ¼ inch in diameter. Spacing is 2½ inches on center to also function as a balustrade.

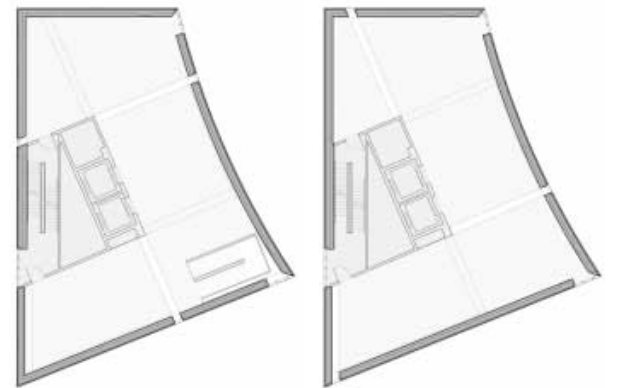
**Right** The second- and third-floor gallery plans.

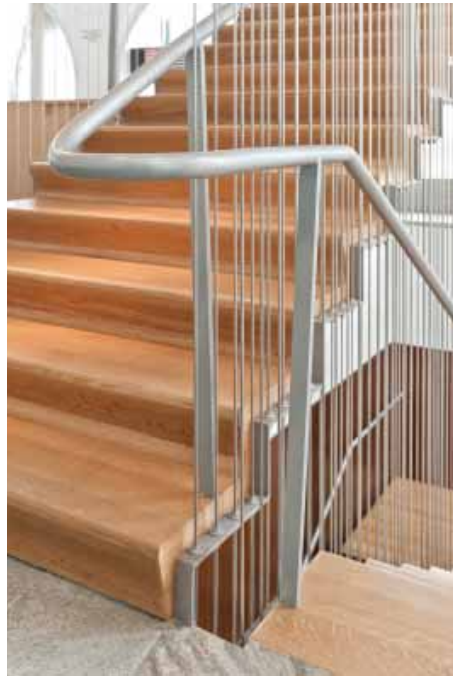
**Facing above** Cables were tensioned by hand at the structural supports, then manually threaded through their corresponding holes and clamped and pinned to the stair's treads.

With assembly completed, the stair sections were delivered to the project site on dollies, then hoisted into place via electric chain fall. Because the finish cables of the stair were only 3 inches from the walls, the cables could not be installed until the walls were finished. "The stair stayed on designed temporary channel supports for months while the walls were finished by other trades," Rifelli says. Indeed, the tight installation required careful project choreography. The plan was to have a maximum amount of finish work completed, with just minimal building structure exposed, when the stair was initially put in place. To finish the stair, the crew welded the sections together—performing on-site bead blasting at the welded location to complete the finish—and then installed and tensioned the cables for the stair. Just as they tensioned the cables by hand at the structural supports, United Iron's crew also performed the meticulous work of manually threading the 300 cables through their corresponding holes, and then of clamping and pinning them to the treads. (White oak tops the riser treads, appearing to cascade down the angular bent steel.) "We didn't have a lot of people doing it," Rifelli says, "but we did have a lot of man-hours."
